Reliability Laboratory

TEST REPORT

Report No.: HC80272/2007
Page: 1 of 4
Date: September 5, 2007

Product Description: TEMWELL BRAND Helical Filter
Style/Item No.: 7H/ No.1~ No.5
Manufacturer/Vendor: Temwell Corporation
Country of Origin: Taiwan
Quantity: Total 5 pieces
Testing Period: Aug. 30, 2007
Note: (Client's declaration) The materials used for 7H series are similar.

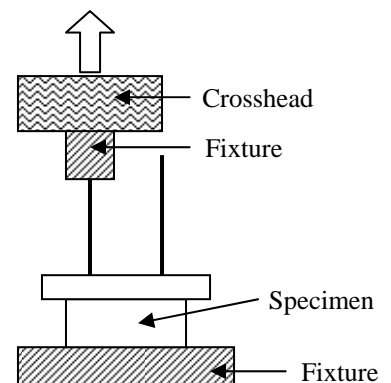
Figure 1 Tensile

With the termination in its normal position and the component held by its body, a specified force shall be applied to the termination in the direction of its axis and acting in a direction away from the body of the component. The force shall be applied progressively and then maintained for a designated duration.

As shown in Figure 1 and in photo 3, 4

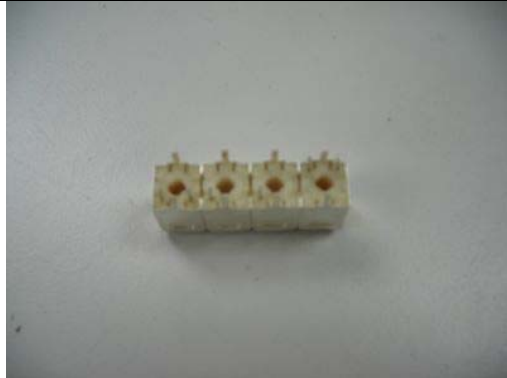
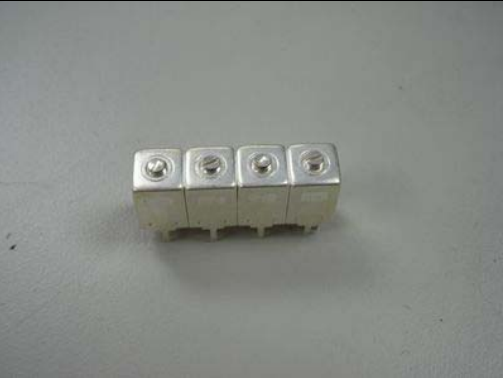
<p>1. Appearance of specimen (7H)</p>	<p>2. Appearance of specimen (7H)</p>

Check Item Style/ Item No.	Appearance check (visual check)
7H/ No.1	No visible damage
7H/ No.2	No visible damage
7H/ No.3	No visible damage
7H/ No.4	No visible damage
7H/ No.5	No visible damage

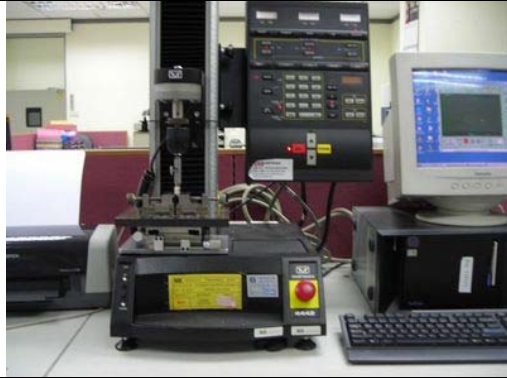
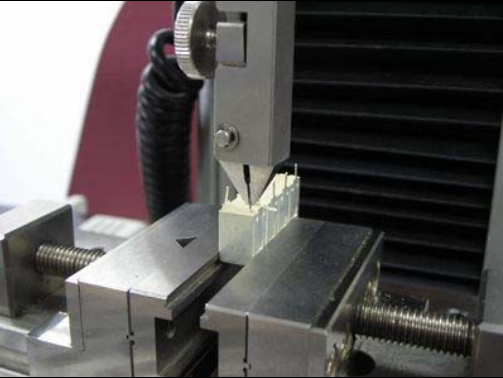
<p>3. Termination Strength test--Tensile</p>	<p>4. Termination Strength test--Tensile</p>
<p>Blank</p>	<p>Blank</p>
